# CHISANA

## HISTORIC STRUCTURE REPORT

THE U.S. COMMISSIONER'S COURT,  
THE U.S. COMMISSIONER'S RESIDENCE, AND THE WOMEN'S JAIL  
CHISANA HISTORIC DISTRICT  
WRANGELL-ST. ELIAS NATIONAL PARK & PRESERVE  
ALASKA

PREPARED BY  
CRAIG W. DAVIS, REGIONAL ARCHEOLOGIST  
DAVID E. SNOW, REGIONAL HISTORICAL ARCHITECT  
ROBERT L. S. SPUDE, REGIONAL HISTORIAN

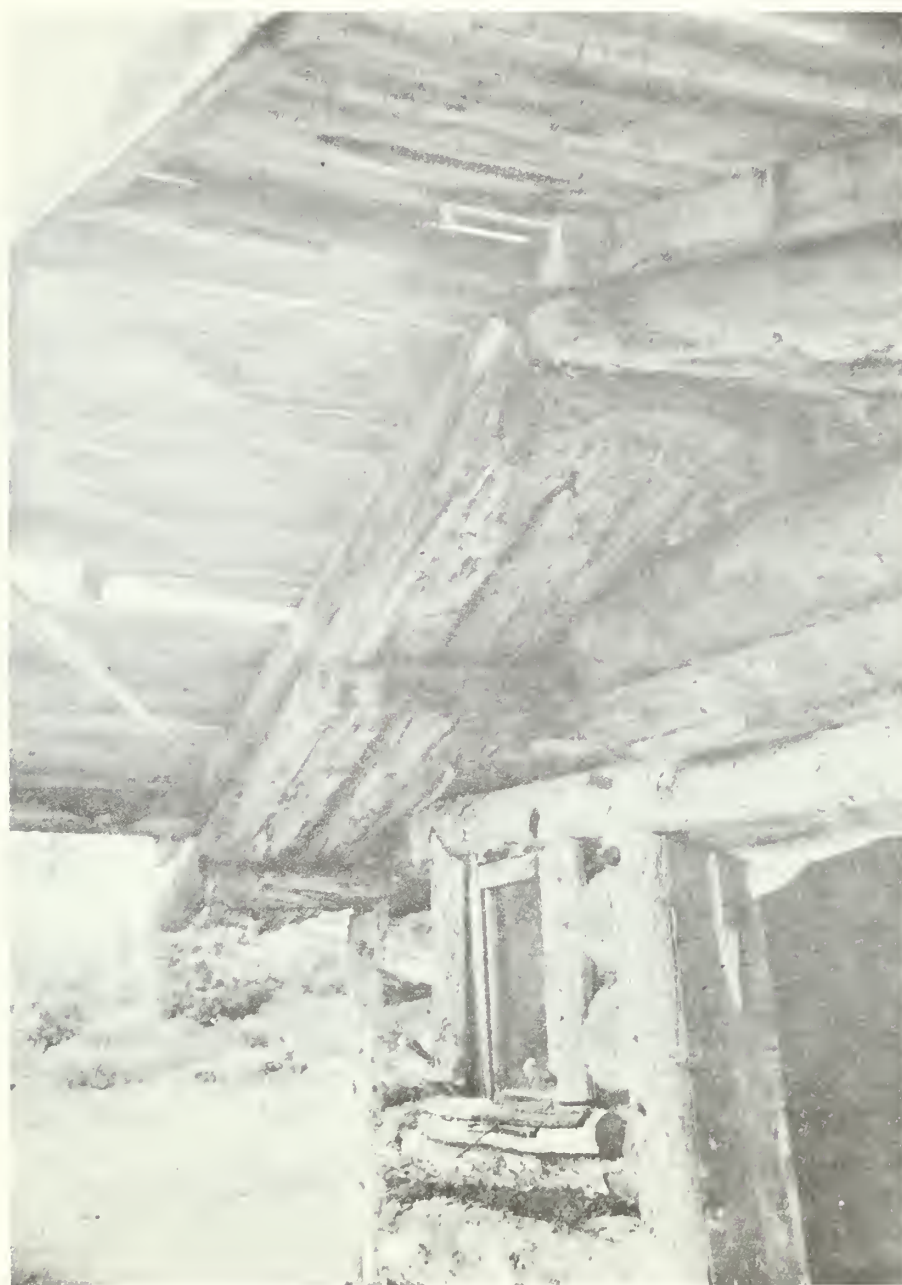
Photograph 37  
U.S. Commissioner's Residence, Chisana  
Newer roof extension over entry on south  
side supported by purlins and ridge board.

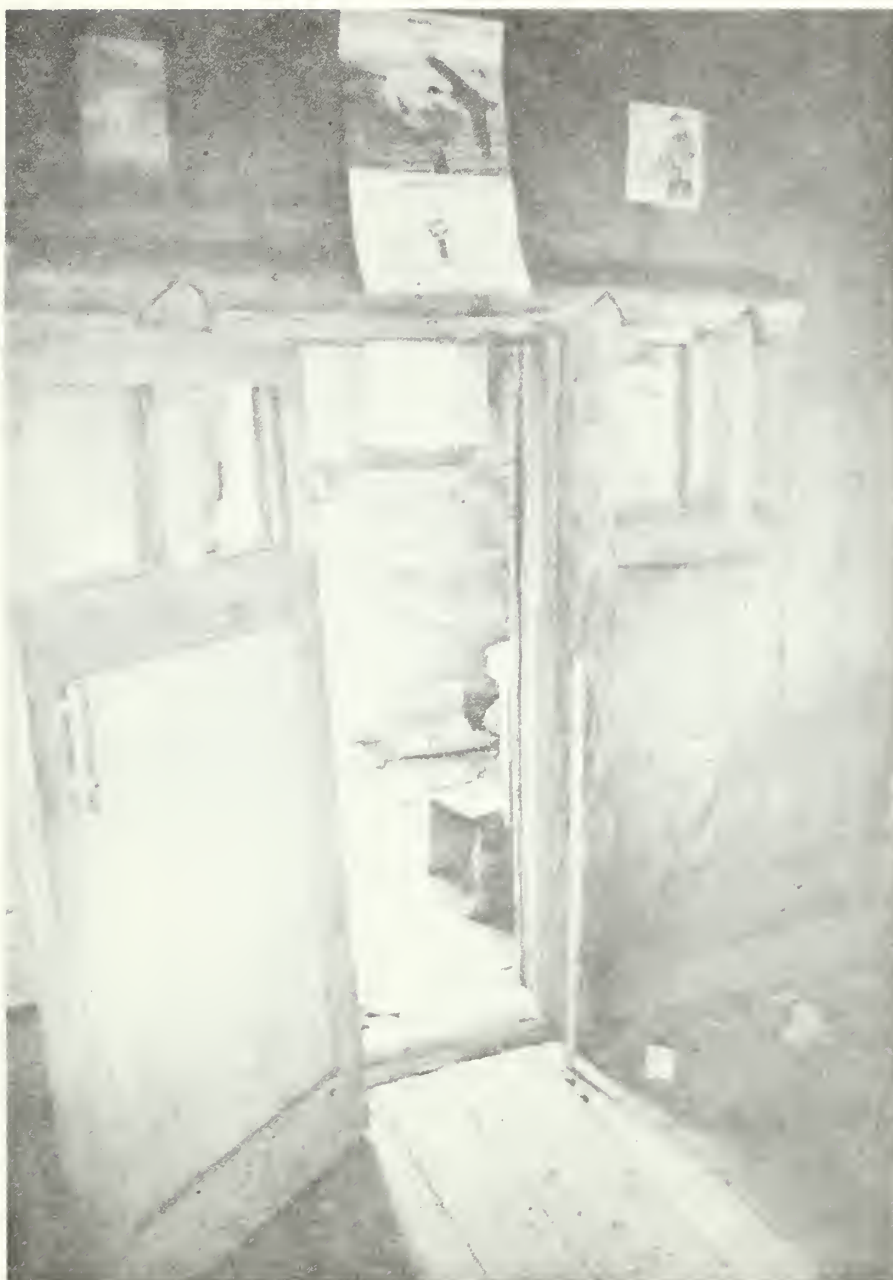
The same green burlap fabric that covers the ceiling also covers the walls. The fabric is brittle in many places. It is water stained around and below leaks and faded where the sun or the heat of the stove strikes it. In places the fabric is held in place with brass upholstery tacks and in others by staples. The water stained areas are decayed and deteriorate at a touch.

Photograph 39  
U.S. Commissioner's Residence, Chisana  
Interior of entry to main cabin - note  
water stained burlap and seperating window  
trim.

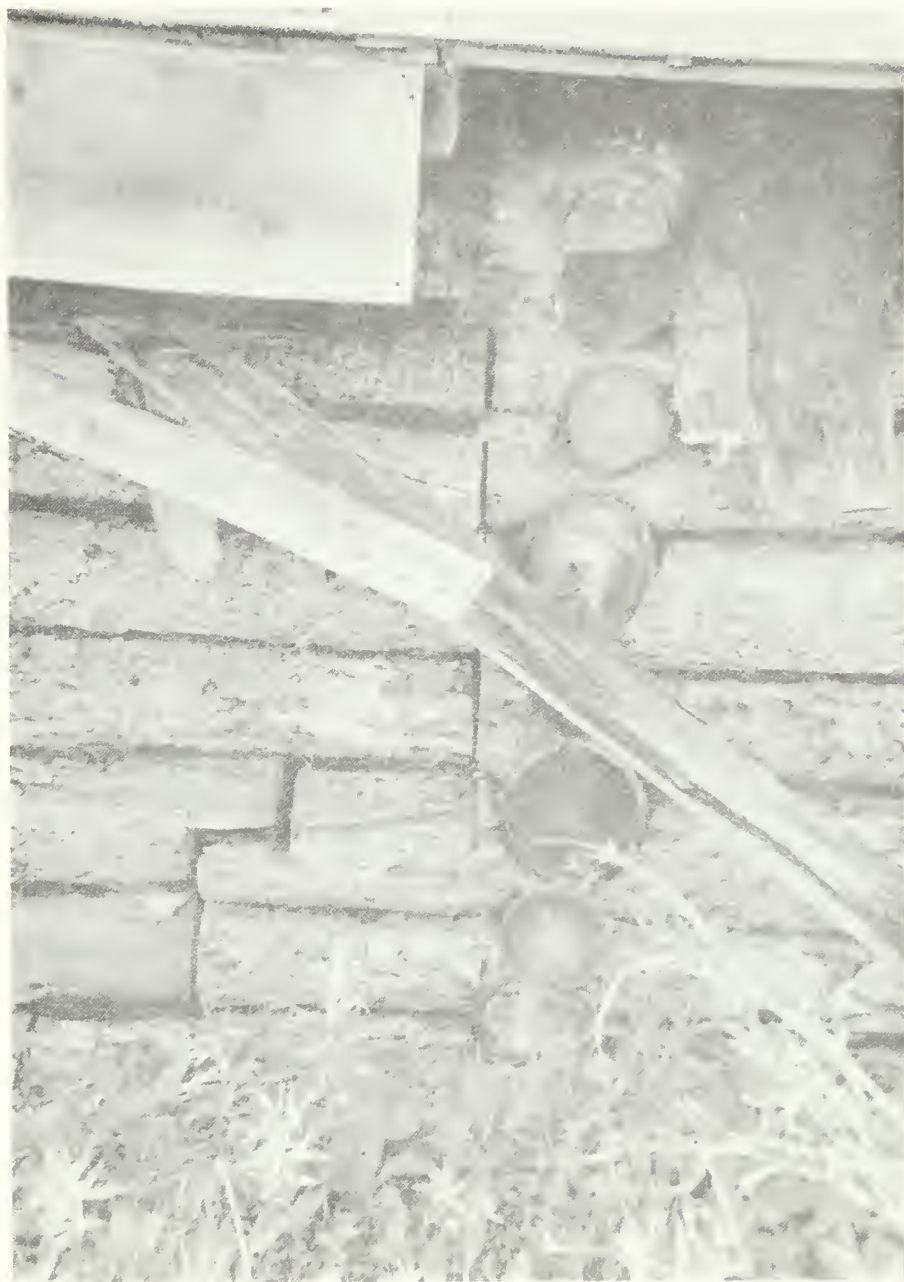
Photograph 40  
U.S. Commissioner's residence, Chisana  
Junction of main cabin logs (right)  
and porch logs.

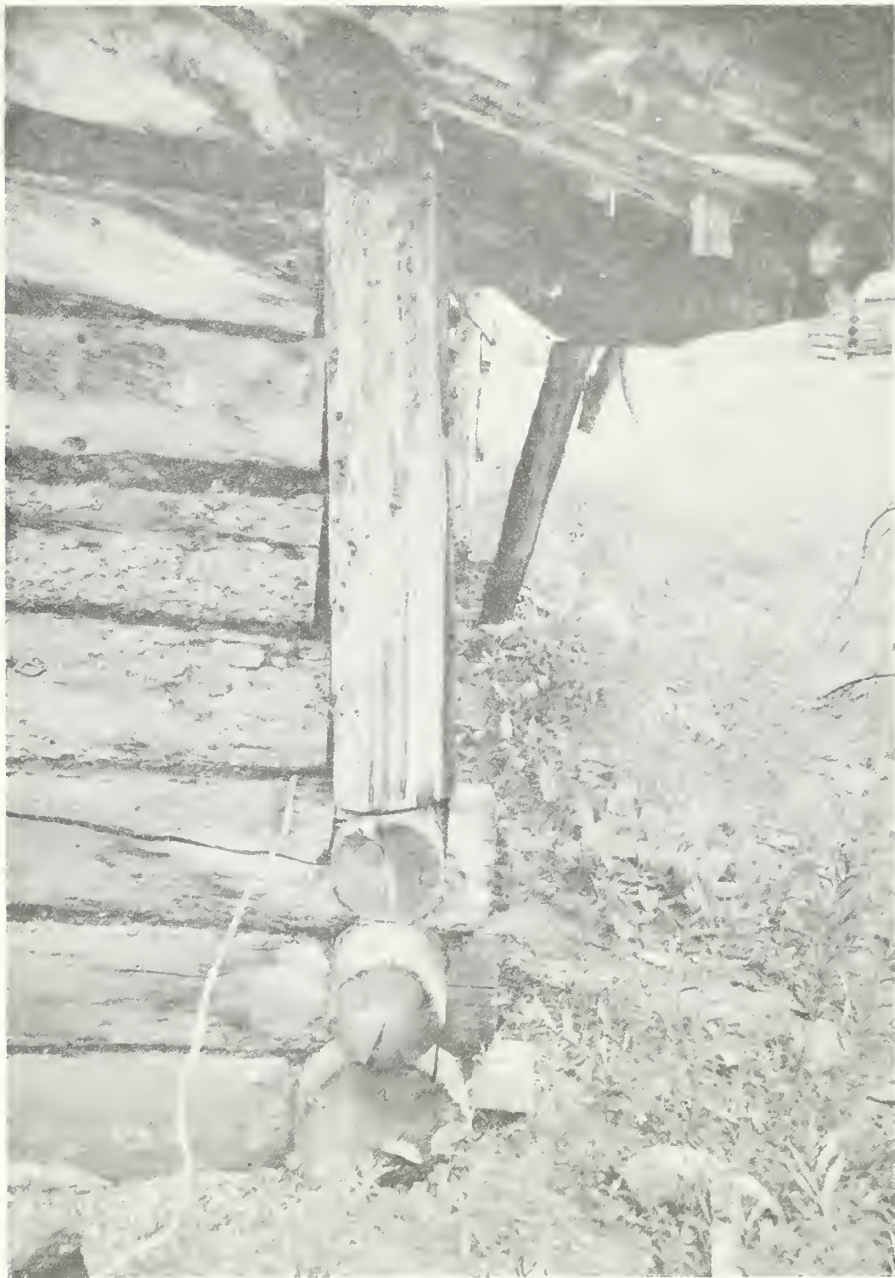
Photograph 41  
U.S. Commissioner's Residence, Chisana  
Hudson Bay post at southeast corner of porch.

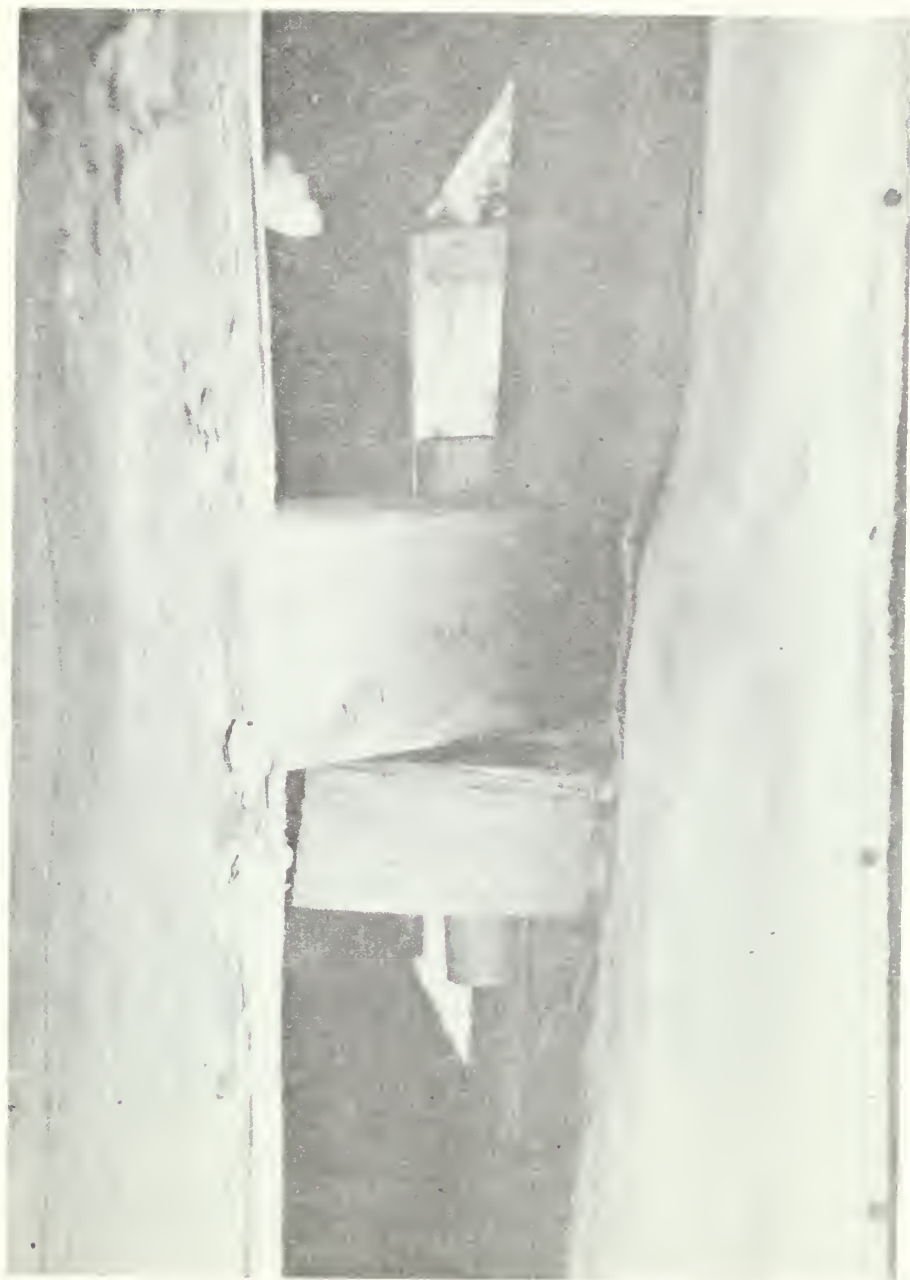
Photograph 43  
U.S. Commissioner's Residence, Chisana  
Detail of wooden hinge on porch door.

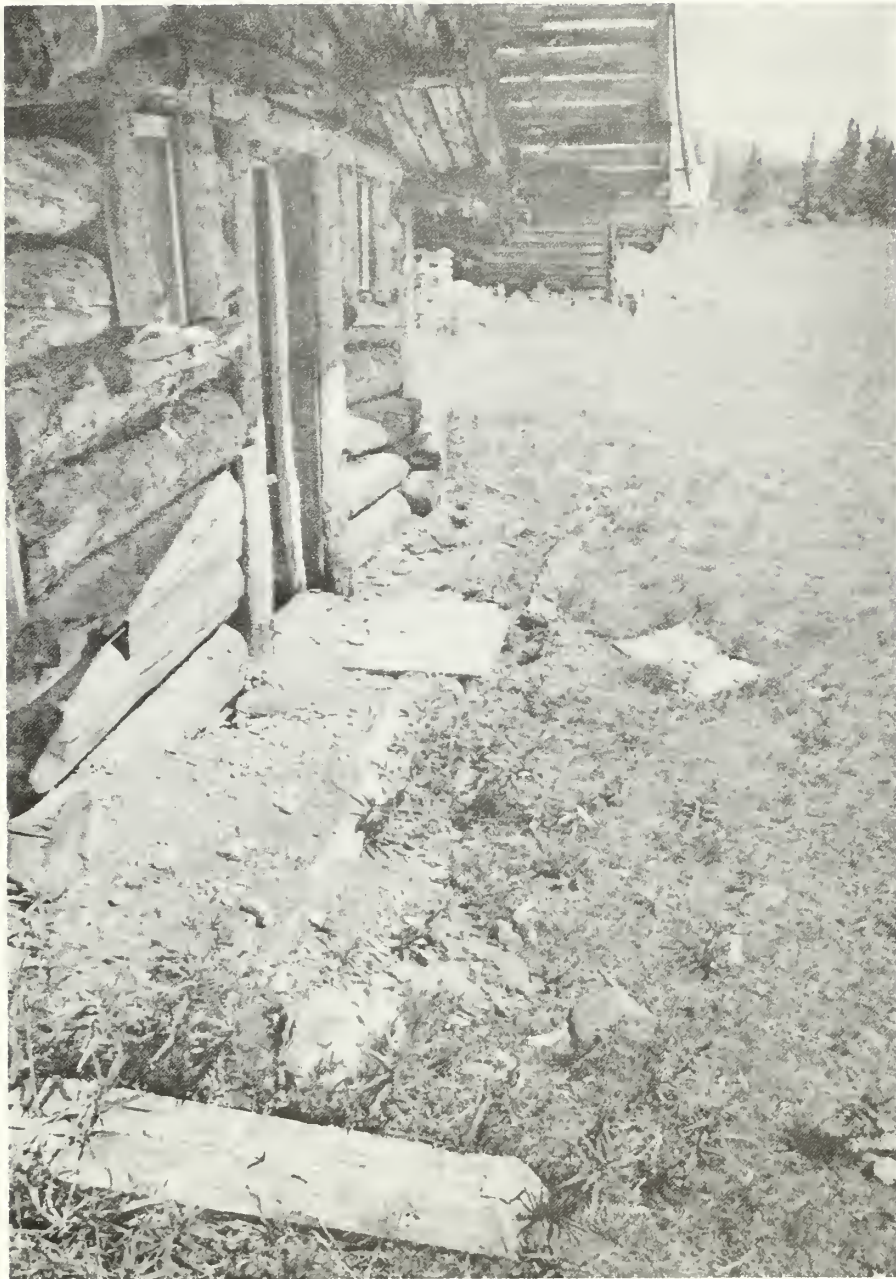
Photograph 44  
U.S. Commissioner's Residence, Chisana  
South end with frame for gravel berming  
around walls.
